# DEVELOPMENT OF IRRIGATION TANK MONITORING SYSTEM AND ITS ENVIRONMENT FOR THE EFFECTIVENESS OF RICE IRRIGATION

To cite this article: SARTIKA T. DEWI, SIHOTANG RICO, MUSLIH MUHAMAD, SITORUS AGUSTAMI, HARIS OSCAR, DEVIANTY, BULAN RAMAYANTY. 2020. Development of Irrigation Tank Monitoring System and Its Environment for the Effectiveness of Rice Irrigation. *Acta Universitatis Agriculturae et Silviculturae Mendelianae Brunensis*, 68(5): 859–865.

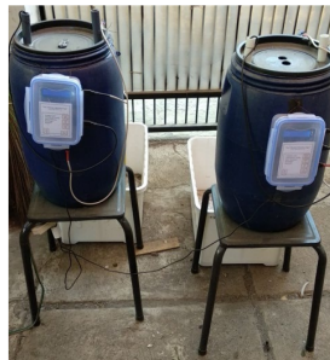
2: Installation of an irrigation tank monitoring system

The mechanism of the irrigation water tank and bed planting is presented in Fig. 2. Two sets of bed planting measuring 400 mm x 700 mm will be planted with rice from water from two containers with a capacity of 30 liters. A bed planting and the tank will be designed using the automatic control method, and one more is done manually. The control box of the monitoring system is placed in the water tank by monitoring water level, ambient temperature and humidity, water temperature, and illuminance from light.

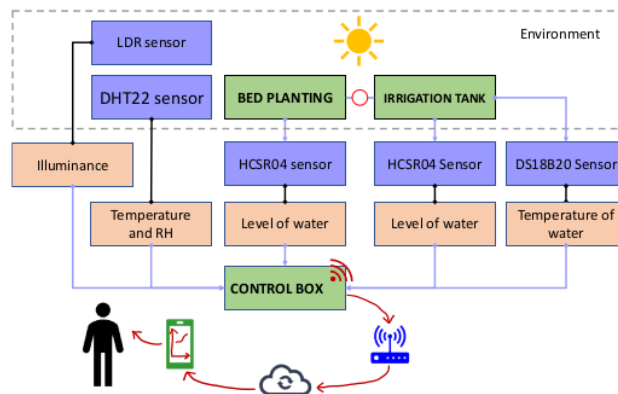
1: Scheme of the monitoring system

The irrigation tank monitoring system and its environment are equipped with several sensors and a microcontroller (Fig. 1). Digital DHT22 sensor is used to measure temperature and humidity

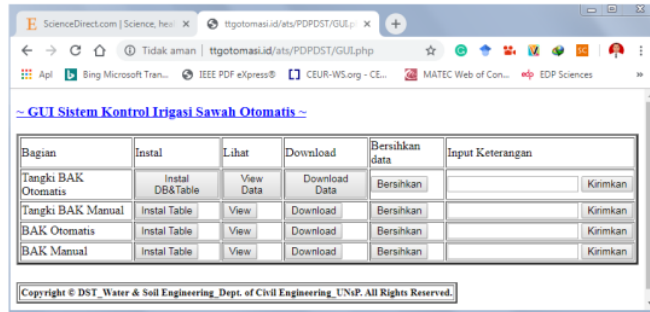
3: GUI irrigation tank monitoring system

- (1) Two control box units were prepared to be able to compare the quality of rice cultivation in a controlled manner manually and with a controlled irrigation system designed as an experiment.
- (2) The recorded data is in the form of environmental data (temperature, RH, sun intensity), and water consumption from aquaculture is monitored online.
- (3) The monitoring system GUI on the irrigation tank is presented in Fig. 3, which can be accessed online through the website link "<http://ttgotomasi.id/ats/PDPDST/GUI.php>".

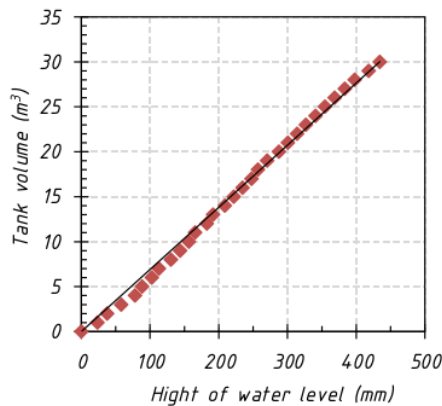
4: Relationship between water level and tank volume

The volume of the irrigation tank will be monitored to be able to find out the water consumption of the rice planting bed (Fig. 4). The sensor with the principle of ultrasonic waves is used to be able to measure the height of the water level inside the irrigation tank. From the height of the water level is then converted using Equation 4, which is found through experimentation into the volume of the irrigation tank. The relationship

between high water level and irrigation tank volume correlates with 99.51%. This shows that the two variables have a close relationship so that it can be used to show the other variables when one of the variables is known.

$$V_T = 0.0691 \times LVL_W, \tag{4}$$

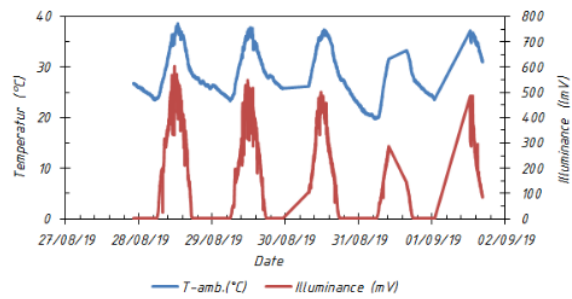
6: Monitoring environmental temperature and solar illuminance in automatic irrigation water tanks

The light illuminance parameter is needed to determine the solar intensity as an environmental parameter that affects plant photosynthesis. The results of recording environmental temperature with solar intensity for automatic plant beds are presented in Fig. 6. It can be seen that light illuminance is in line with environmental temperature conditions (Li and Lou, 2018). It shows that the illuminance of light dramatically affects the environmental temperature conditions around the irrigation tank. Light illuminations in the highest and lowest daily mV units are 485.41 mV, 2.22 mV, respectively.

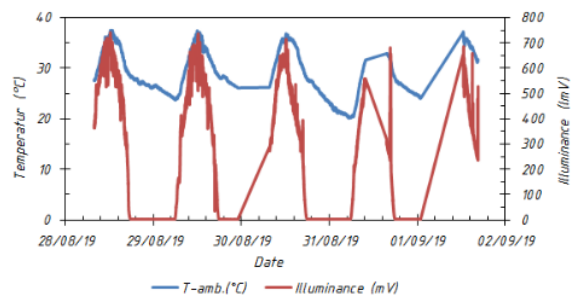
8: Monitoring environmental temperature and solar illuminance in manual irrigation water tanks

The light illuminance parameter is needed to determine the solar intensity as an environmental parameter that affects plant photosynthesis. The results of recording ambient temperature with solar intensity for manual plant beds are presented in Fig. 8. It can be seen that light illuminance is in line with environmental temperature conditions (Li and Lou, 2018). This shows that the illuminance of light greatly affects the environmental temperature conditions around the irrigation tank. Light illuminations in the highest and lowest daily mV units are 711.26 mV, 2.22 mV, respectively.
